ANALYSIS OF LOW POWER ISSUES IN KOMATSU D85ESS-2 DOZER ENGINES

Hendro Purwono^{1*}, Rasma², Ari Aryadi³, Bambang Setiawan⁴, Ade Darmaji⁵

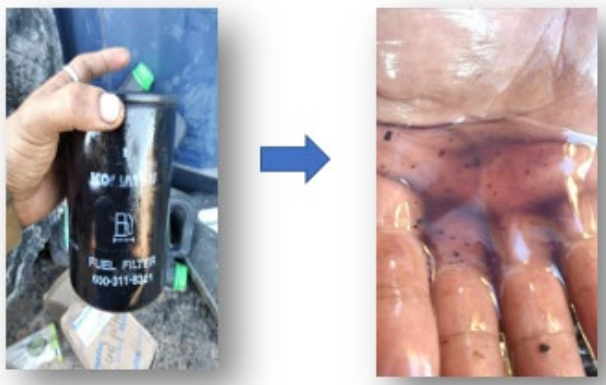
- **Strainer Feed Pump:** This component is in good condition without any dirt, which supports uninterrupted fuel delivery to the engine.
- **Fuel Filter:** The sediment found here restricts fuel flow, likely contributing to the low power issue. Cleaning or replacement is needed to ensure full, consistent fuel supply to the injection system.

Figure 3. Fuel Filter Problem

Based on the inspection results, it was concluded that the occurrence of low engine power was primarily due to a blockage in the fuel filter, which restricted optimal fuel flow to the engine. This restriction hindered fuel delivery, leading to a decrease in engine performance. As an initial step, the fuel filter was cleaned to temporarily restore fuel flow; however, to prevent recurring issues and to optimize engine performance, it was determined that replacing the fuel filter entirely would be the most effective solution. By installing a new filter, the engine's fuel supply will be ensured, promoting consistent and efficient operation in the long term. This proactive replacement strategy is essential to maintaining the reliability of the unit and avoiding potential downtimes due to fuel-related inefficiencies.

This diagnostic data suggests that, while most components are in optimal condition, issues with the fuel tank strainer and fuel filter are impairing engine power. Proper maintenance, including cleaning and possibly replacing these parts, would likely resolve the low-power issue and improve the unit's operational efficiency.
