# ANALYSIS OF LOW POWER ISSUES IN KOMATSU D85ESS-2 DOZER ENGINES

Hendro Purwono<sup>1\*</sup>, Rasma<sup>2</sup>, Ari Aryadi<sup>3</sup>, Bambang Setiawan<sup>4</sup>, Ade Darmaji<sup>5</sup>

<sup>12345</sup>Department of Heavy Equipment and Automotive Engineering, Faculty of Engineering, Universitas Muhammadiyah Jakarta, Jl. Cempaka Putih Tengah 27, Jakarta 10510, Indonesia

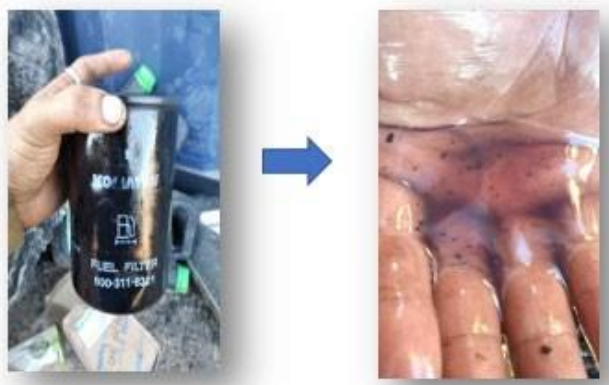
Air Cleaner	No damage or dirt detected on air cleaner.	Clean and undamaged	OK
Engine Speed	Low Idle: 809 RPM; High Idle: 2080 RPM; Stall Speed: 1792 RPM	Low Idle: 800-850 RPM; High Idle: 2,050-2,150 RPM; Stall Speed: 1,600-1,850 RPM	OK
Strainer Fuel Tank	Dirt present in fuel tank strainer.	Clean and undamaged	NOT OK
Water Separator	No water mixed with fuel.	No water mixed with fuel	OK
Strainer Feed Pump	Strainer feed pump in good and clean condition, no dirt.	Clean and undamaged	OK
Fuel Filter	Sediment in fuel filter obstructing optimal fuel flow.	Clean and unblocked	NOT OK

- **Strainer Feed Pump:** This component is in good condition without any dirt, which supports uninterrupted fuel delivery to the engine.
- **Fuel Filter:** The sediment found here restricts fuel flow, likely contributing to the low power issue. Cleaning or replacement is needed to ensure full, consistent fuel supply to the injection system.

**Figure 4.** Fuel Filter Problem

Based on the inspection results, it was concluded that the occurrence of low engine power was primarily due to a blockage in the fuel filter, which restricted optimal fuel flow to the engine. This restriction hindered fuel delivery, leading to a decrease in engine performance. As an initial step, the fuel filter was cleaned to temporarily restore fuel flow; however, to prevent recurring issues and to optimize engine performance, it was determined that replacing the fuel filter entirely would be the most effective solution. By installing a new filter, the engine's fuel supply will be ensured, promoting consistent and efficient operation in the long term. This proactive replacement strategy is essential to maintaining the reliability of the unit and avoiding potential downtimes due to fuel-related inefficiencies.
