Analysis Structure and Function Cooling System on Unit D155A-6

Unit D155A-6

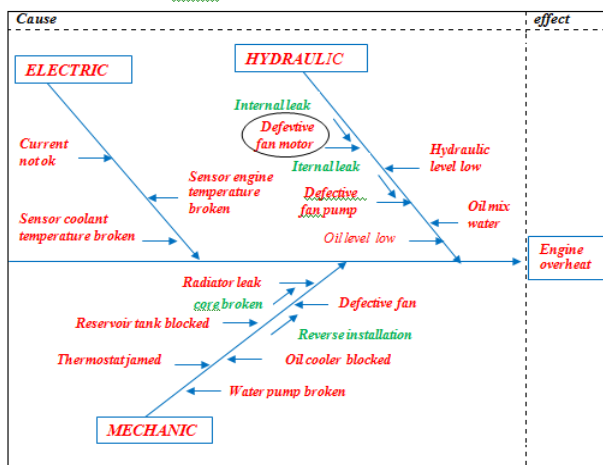
Fig. 2. Possibility cause

As per the data below, it was checked from the simplest method where the engine overheated after being operated for 2-3 hours, ambient temperature in the range of 30-33°C and the unit experienced engine overheat problem at 15358 of HM as shown in Figure 2.

Symptom : Engine overheat
 Unit model : D155A-6
 Data / HM : 15358

Possible Root Cause	Check	Root Cause
HYDRAULIC		
Oil engine low	Oil engine ok	No
Oil mix water	Oil not mix water	No
Hydraulic level low	Leveling hydraulic tank ok	No
Reducing valve broken	Reducing valve ok	No
<u>Defective fan motor</u>	<u>Pressure fan motor not ok</u>	<u>Yes</u>
Defective fan pump	Pressure fan pump ok, not internal leak	No
MECHANICAL		
Radiator leak	Radiator ok	No
Defective fan	Fan installing ok, not broken	No
Reservoir tank blocked	Reservoir tank ok	No
Ruber radiator broken	Ruber radiator ok	No
Strainer hydraulic tank blocked	Strainer blocked and facum, replacement	No
Belt selip (if make belt)	Make fan motor	No
Oil cooler blocked	Belum dilakukan cek	No
Thermostat jammed	Belum dilakukan cek	No
Water pump leak	Water pump ok	No
ELECTRICAL		
Sensor coolant temperature broken	Belum dilakukan cek	No
Sensor engine temperature broken	Belum dilakukan cek	No
Current not ok	Current ok	No

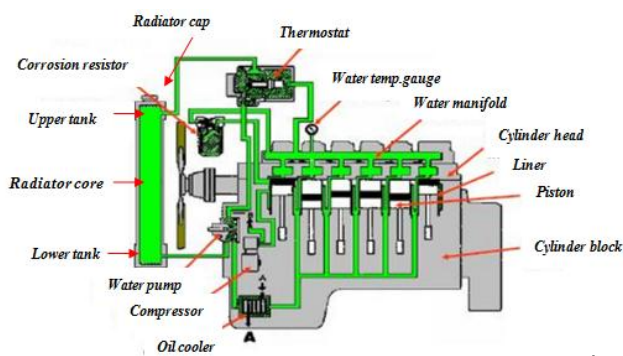
Fig. 3. Structure engine cooling system

Basic analysis to determine the suspected cause: From the results of the examination can be concluded that the fan motor rotation is not achieved because the internal leak exceeds the allowable standard. Because all the pressure control fan pump and pressure output from the fan pump are in standard conditions. Internal leak can occur due to excessive wear in the motor fane component. Of these problems that cause nonstandard fan rotation and cooling in the cooling system to be less than maximum can be seen in Figure 3 and Table 5.

Component	Analysis		
	Standard measure	Actual	Note
Fan pump	15,7 ± 2,5 MPa {160±25kg/cm ² }	16 MPa	Ok
Self reducing valve	3,78 - 4,46 MPa {38,5-45,5kg/cm ² }	4,1 MPa	Ok
Internal leakage fan motor	Max. 2000-3000 cc/ 60 detik	± 3000-4000 cc/ 6 detik	Not ok
Fan motormode 100%	13,5-18 MPa 1150-1300 Rpm	8,5 MPa 780 Rpm	Not ok

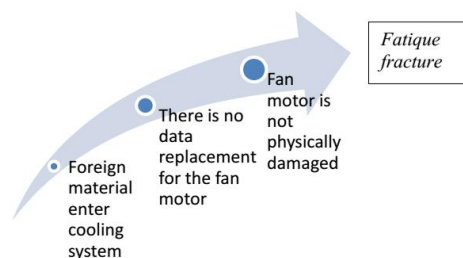
Fig. 4. Suspected cause

Possible root problems related to the cause of the problem. Possible causes of damage can be caused by many things, including foreign material entering the cooling system such as dust when hose replacement is sometimes contained in dust, so in hose replacement it is better to pressurized wind first, or when replacing or adding hydraulic oil can also foreign material enters the cooling system so make sure the cleanliness around the filling hole and others, then the absence of the previous motor fan replacement data, physically the fan motor does not look damaged, and concluded the fan motor is damaged probably because fatigue fracture can be seen in Figure 4.

From the results of analysis, checking and data collection, it can be concluded that the occurrence of trouble Engine Overheat in this case is caused by the external leakage that is too large in the fan motor, so that the cooling fan rotation is not achieved, causing cooling by the cooling fan to cool the radiator does not work optimally, the effect of coolant experiencing a temperature rise too fast and not cooled to the maximum causes the engine not to be cooled to the maximum until the temperature is too high or the engine overheats.
