Troubleshooting Blow by Pressure High on the Komatsu Bulldozer Unit D375A-6R

Hasan Basri^{1*}, Ery Diniardi², Anwar Ilmar Ramadhan³

¹Department of Automotive and Heavy Equipment, Faculty of Engineering, Universitas Muhammadiyah Jakarta, Indonesia

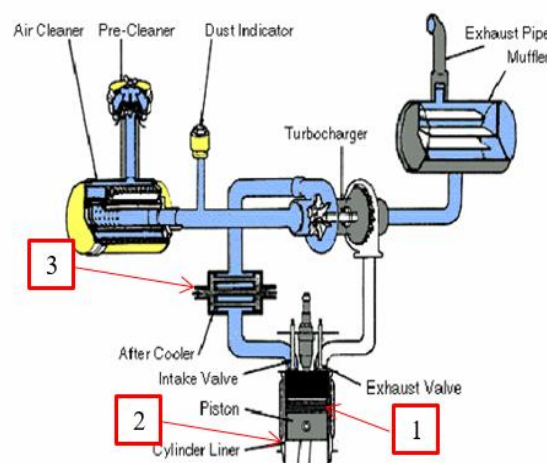
Fig. 3. Air intake system

In this troubleshooting the main cause of blow by high pressure is the occurrence of wear on the piston ring (1) and cylinder liner (2) which causes compression on each cylinder to be low compression, which should have a standard compression of 2.94 kPa. The most severe low compression occurs in cylinders no. 5 and 6 have been seen when doing compression testing using a compression tester when in the field, the cause of rising blow by pressure and the occurrence of low compression is because the air during the compression process carried out by the piston was leaking into the crankcase room. What causes wear and tear on the piston ring and cylinder liner is the occurrence of cracks which cause leakage in the after cooler (3) which causes dust & dirt to enter the air intake system circulation. The entry of dust and other impurities is caused by air pressure & the rate in the after cooler (3) is high so that the dust gets sucked into the after cooler.

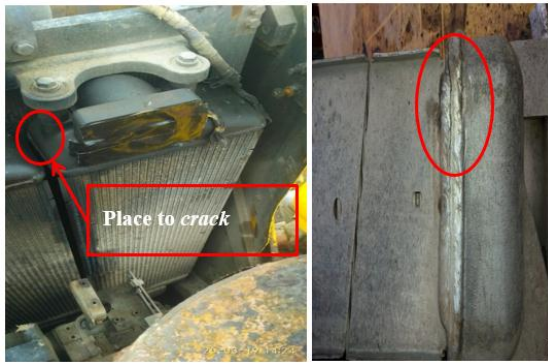
Fig. 4. Aftercooler crack

Allegedly the oil that gushes out through the engine oil fill hole due to increased blow by pressure due to cracks in the after cooler which causes dust and dirt into the air intake system and causes the piston, piston ring and cylinder liner to wear excessively so from the results of previous analyzes need to do repairs on the cracked after cooler housing to prevent dust from entering the circulation air intake system due to a leak in the after cooler.

After knowing what causes trouble, the handling steps are by overhauling the engine, removing all cylinder liners, and measuring / measuring the cylinder liner and piston.

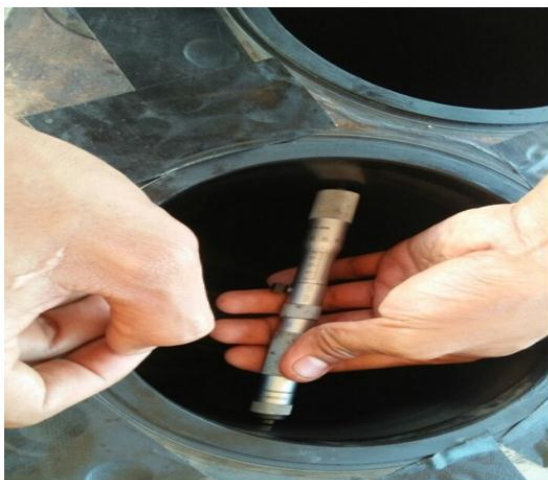
Fig. 6. Measuring cylinder liner

DAMBAR KERJA	NO	NAMA COMP	UNIT	SPESIAL	KONDISI YANG HARUS DIPERIKSA	HASIL PEMERIKSAAN	REVISI
	7	Cylinder liner	C		Kondisi piring dan kekusutan.	ACTUAL:	
					D. D cylinder liner mm STANDARD Tolerance R. Limit 178 +0.04 g 179.24	Di 1 Di 2 Di 3 Di 4 X 179.08 179.05 179.20 179.14 179.17 179.21 Y 179.08 179.16 179.20 179.16 179.13 Z 179.05 179.05 179.08 179.07 179.15 179.14 2 179.05 179.14 179.16 179.16 179.05 179.14 2 179.08 179.14 179.16 179.16 179.05 179.14	
					Rounder cylinder liner Repair limit : 0.020 mm Actual : mm		
					Cylinderly cylinder liner Repair limit : 0.020 mm Actual : mm		
					Ketebalan jekason dan scrach. Check thread pada rear dan front crankshaft. Check dan bersihkan lubang pelumasan.		
					O.D. Main bearing journal (2) mm ACTUAL:		
					Std Size Toler R. limit		
					STD 146 0 139.81		
					0.25 US 139.75 -0.025 139.66		
					0.50 US 139.50 -0.025 139.41
