Analysis Systems of Aftercooler on Bulldozer D375A-6R

Hasan Basri^{1*}, Jaref Darmawan¹, Ery Diniardi², A I Ramadhan², Firmansyah²

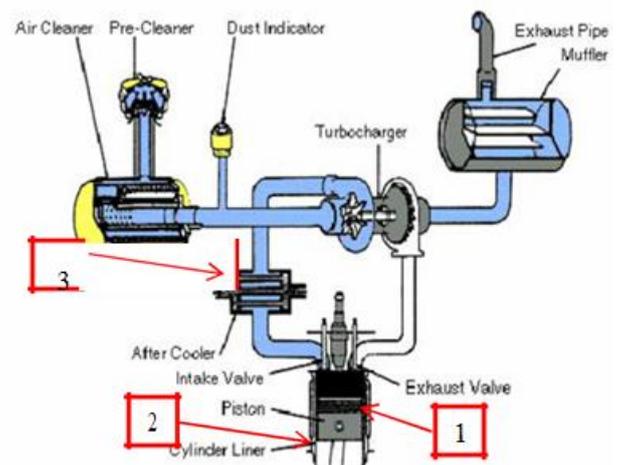
In this troubleshooting the main cause of blow by high pressure is the occurrence of wear on the piston ring (1) and cylinder liner (2) which results in compression on each cylinder to be low compression which should have a standard compression of 2.94 kPa. The most severe low compression occurs in cylinders no. 5 and 6 have been seen when doing compression testing using a compression tester when in the field, the cause of rising blow by pressure and the occurrence of low compression is because the air during the compression process carried out by the piston was leaked into the crankcase room. What causes wear and tear on the piston ring and cylinder liner is the occurrence of cracks which cause leakage in the after cooler (3) which causes dust and dirt to enter the air intake system circulation. The entry of dust and other impurities is caused by air pressure and the rate in the after cooler (3) is high so that the dust gets sucked into the after cooler.

Fig. 4. Air intake system

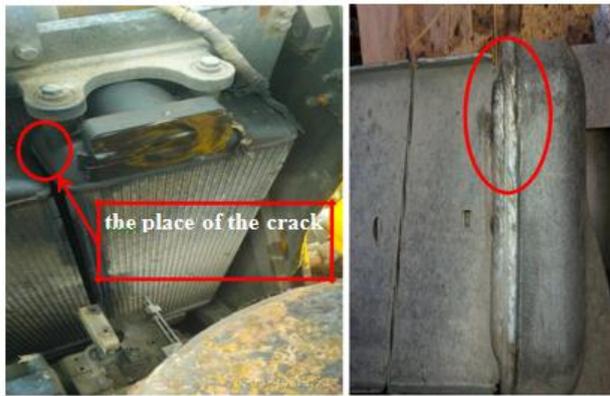
Allegedly the oil that gushes out through the engine oil fill hole due to increased blow by pressure due to cracks in the after cooler which causes dust and dirt into the air intake system and causes the piston, piston ring and cylinder liner to wear excessively so from the results of previous analyzes need to do repairs on the cracked after cooler housing so that there is no dust coming back into the air intake system circulation due to a leak in the after cooler.

Fig. 5. After cooler crack

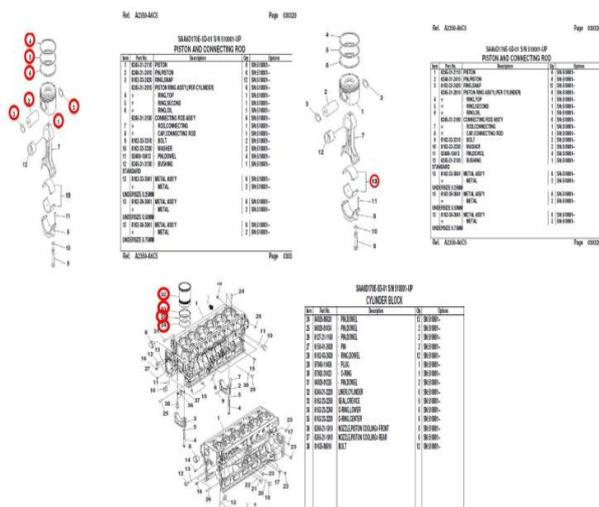
Fig. 6. Part Replace (Standard part overhaul)

From the results of checking above, it can be concluded that the occurrence of Blow by high on the D375A-6R is caused by, broken piston rings, worn pistons and scratch liner cylinders, broken piston rings, worn pistons and scratch liner cylinders caused by leakage in the after cooler which creates dust and dirt enters the combustion chamber thereby indicating excessive friction between the piston ring, piston and cylinder liner. So in this troubleshooting that must be done is to overhaul and replace and repair parts.

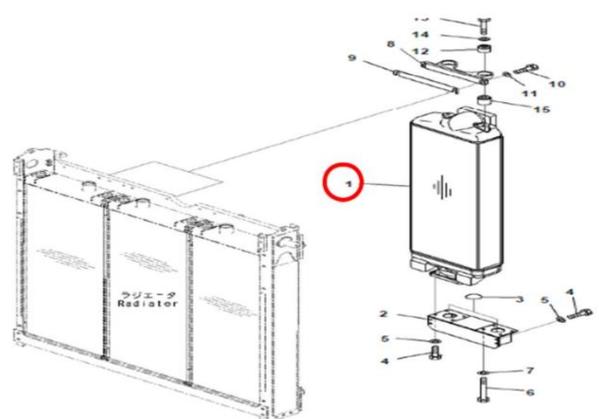
Fig. 7. Part repair (after cooler)
