## Analysis Abnormal of Engine Noise in UD Truck Quester CWE 370 Unit

<sup>1</sup>Automotive & Heavy Equipment Engineering Department/ Faculty of Engineering, University of Muhammadiyah Jakarta, Indonesia

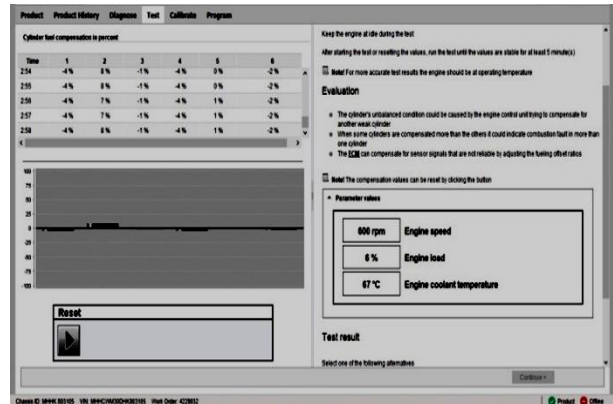
Figure 5: Cylinder balancing test

Data was collected by, among others, conducting visual inspections, interviews with operators and using tech tool software as diagnostic test software used by UD Trucks. Cylinder balancing testing using tech tool software. The goal is to see any indications of abnormalities in each combustion chamber. The test was conducted for 15 minutes, low engine rotation speed of 600 rpm with neutral gear position. From the test results, it can be seen that the percentage of compensation on the lowest fuel cylinder is at -4% and the highest at 8%. It can be concluded that the cylinder is in the state of balance shown in figure 5.

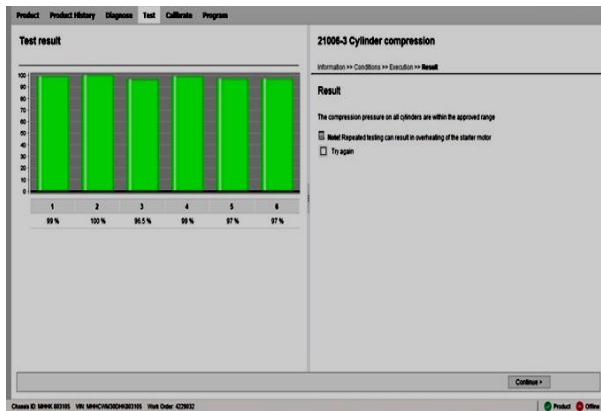
Cylinder compression test using Tech Tool software. The goal is to see an indication of compression pressure in each combustion chamber. Tests are carried out when the engine is off, the gas pedal or accelerator is released or not stepped on, the coolant liquid temperature on the engine is above 60°C and the gear position is neutral. From the test results, it can be seen that the percentage of compensation in the fuel cylinder is in the highest position, 100%, the lowest is in the 98% position, shown in figure 6. It can be concluded that the compression on the cylinders is in good condition.

Figure 6: Cylinder compression test  
Camshaft Crank Test is a test carried out by rotating the flywheel using a turning tool or crank adapter. The purpose of this test is to find unnatural sounds on the camshaft or on the cross head on the rockerarm. Camshaft crank test is performed in the following way:

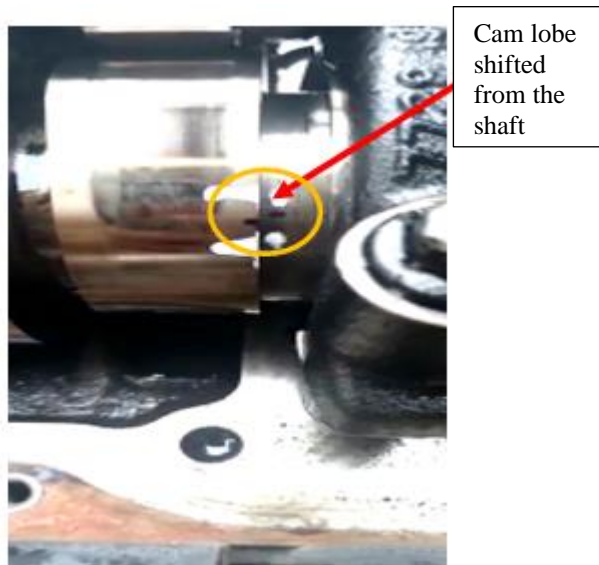
Figure 7: Camshaft crank test

The results of testing on the camshaft using a camshaft crank test, showed the cam lobe had shifted from its shaft. Under normal conditions, the cam lobe should be in a position parallel to the shaft. This is the cause of abnormal engine noise. The recommended action is to make a replacement on its camshaft unit. can be seen in figure 7.

After step-by-step troubleshooting, it can be concluded that the abnormal engine noise problem on the UD Truck Quester CWE 370 unit is caused by the cam lobe contained in the camshaft has shifted from its position. This is due to wear on the camshaft due to the high hour meter. After finding the cause of abnormal engine noise, the next step is to determine the repair steps, namely by replacing or replacing the camshaft.

Abnormal engine noise that occurs in UD Truck Quester CWE 370 units is a problem that can occur on any machine that is generally characterized by a rougher than usual engine sound. After troubleshooting the UD Truck Quester CWE 370 unit, it can be concluded as follows: The cause of abnormal engine noise is wear on the camshaft which causes the cam lobe to shift from its position. Wear can occur due to Camshafts that have experienced a fairly high hourmeter above 12,000 HM or 3 years after the purchase and delivery of the unit. Replacement of one camshaft unit is highly recommended, because it can spread to other cam lobes.
