THE EFFECT OF SANDBLASTING AND AIRLESS SPRAY COATING MISMATCHES ON THE LIFE OF A STEEL BUILDING

Nur Siska Faradilla^{1,*}, Deri Teguh Santoso¹, Oleh¹

¹Department of Mechanical Engineering, Faculty of Engineering, Universitas Singaperbangsa Karawang, Karawang, 41361, Indonesia

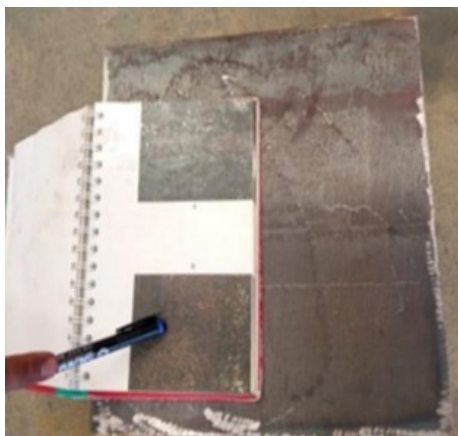
layer. The rust grade inspection revealed that the steel is at level B, indicating that the surface has started to rust, and some of the outer layers have begun to peel off. Below is an image showing the results of the rust grade inspection (Figure 2).

Figure 2. Rust Grade

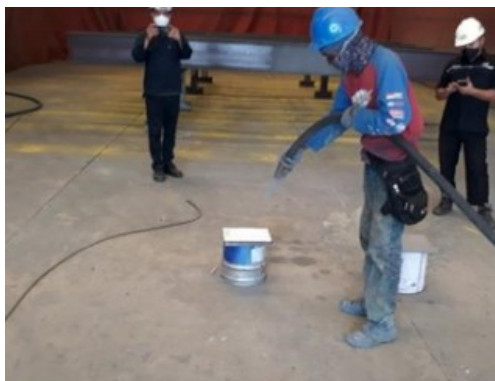
- c. A blotter test, standardized by ASTM D 4285, is conducted to determine if the air compressor contains oil or water. This test confirmed that no oil or water was found in the air compressor (Figure 2).

Figure 3. Blotter test

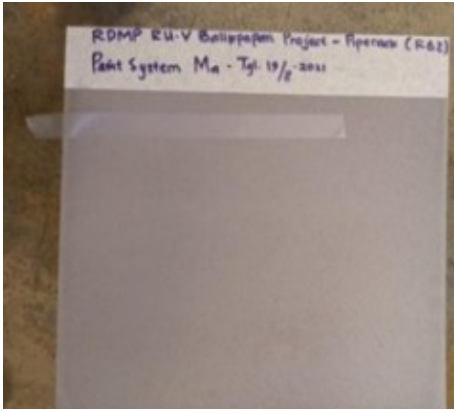
- a. Checking the cleanliness level of the steel surface that has undergone sandblasting, specifically regarding rust. This is done by visually comparing the steel with a standardized rust level reference. The result achieved is that the steel reaches a Sa3 cleanliness level.
- b. Conducting a dust assessment test by applying a clear adhesive to detect any dust adhering to the steel. The result obtained is at level 2, indicating an acceptable level of dust that allows for proceeding with the next coating layer.

Figure 4. Dust Assement Test

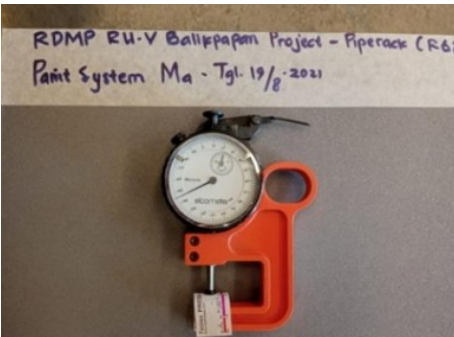
- c. Checking the thickness of the blasting layer using a thickness gauge applied to the steel. The result obtained is a thickness of 95 microns.

Figure 5. Thickness Of the Blasting Layer

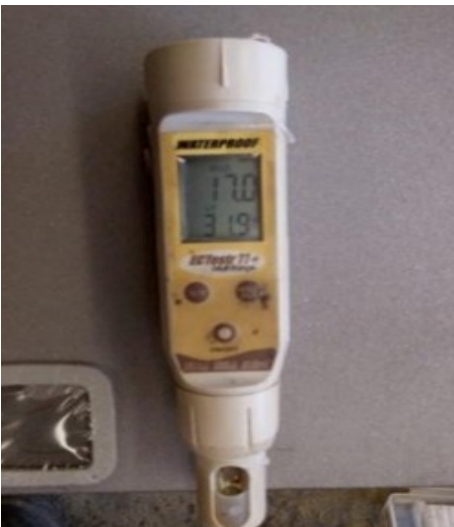
- d. Measuring the oxidation levels of water and salt solutions using an ORP meter. The result for water oxidation is $5,7 \frac{\mu S}{cm}$ and the salt content calculated is $(17-5,7) \frac{\mu S}{cm} \times 1,2 = 11,3 \frac{mg}{m^2}$.

Figure 6. Salt Content Check Result

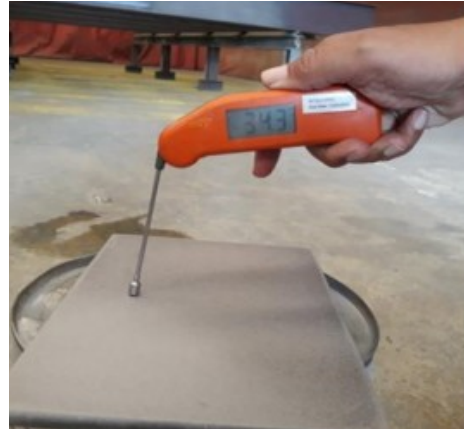
Figure 7. Check The Steel Temperature

- e. Inspecting the area to be used for painting application, similar to the inspection process for surface preparation.
- f. Measuring the temperature of the steel to be coated with paint, ensuring it is in accordance with standards and customer requirements.

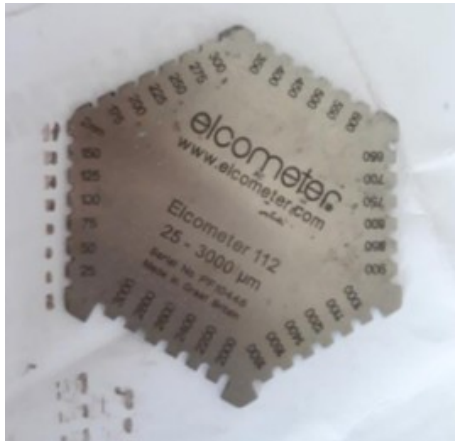
before solvent evaporation. The result of this check is 150 μm (Figure 8).

Figure 8. WFT Check

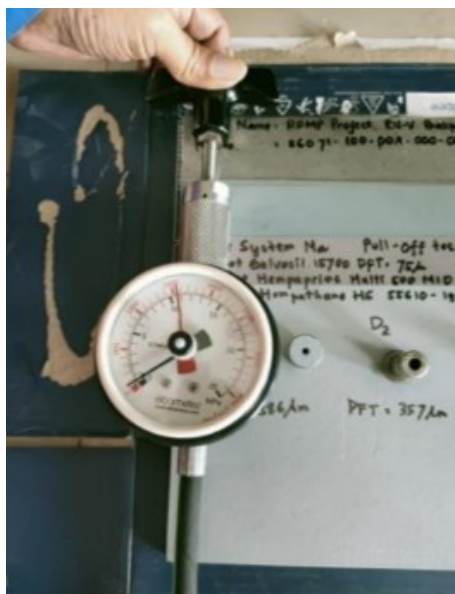
The pull-off test is conducted to determine the adhesion strength of the paint layer after application, using a pull-off adhesion tester. The result obtained from this test is 11 MPa, and the paint failure mode is 100% cohesive failure of the topcoat layer (Figure 9).

Figure 9. Pull of Test
