Study of the Placement of Fire Extinguishers at the R.A. Kartini Museum Rembang using Space Syntax Analysis

Emhade Arman Erhaqim¹, Siti Zulfa Yuzni²

¹ Department of Architecture, Institut Modern Arsitektur dan Teknologi, Kab. Deli Serdang, Indonesia

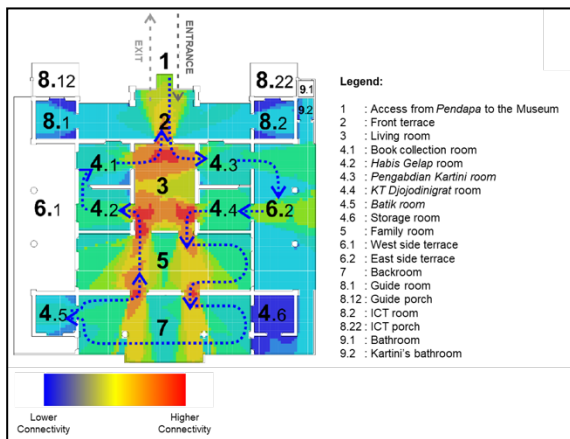
Figure 5. VGA Simulation Results of R.A. Kartini Museum Rembang floorplan.

According to the VGA simulation results of the museum floorplan (See Figure 5 & Figure 6), the analysis reveals that the most excellent connectivity is concentrated in the northern and southern areas of the central room and family room. Within the living room, optimal connectivity is observed in the access points to adjacent rooms. In contrast, in the family room, the highest connectivity is found at the entrances leading to the living room and back room.

The areas highlighted in green-blue (See Figure 5) in the simulation results indicate sections requiring additional attention for strategically positioning attractors, thereby enhancing visitor engagement and exploration within the room.

In the storage room, the connectivity is observed to be the lowest among all areas analyzed. Despite this, the functionality and connectivity of this room remain robust, as it operates independently of visitor traffic flow, thereby minimizing disruptions to their exploration of the museum space.

Conversely, the batik room needs better connectivity, necessitating a heightened emphasis on attracting visitor attention compared to other exhibition areas. Enhancing the attractiveness of this room through strategic placement of attractors becomes imperative to foster visitor engagement and encourage exploration within this space.

Areas highlighted in yellow-red denote sections characterized by high connectivity, indicating heightened visitor interaction and attention. These regions serve as crucial focal points for visitor exploration. However, there remains a notable deficiency in the arrangement and security measures concerning emergency preparedness. Key information regarding the location of safety equipment, including evacuation routes and gathering points, is notably absent. Additional details encompassing the museum's overall floorplan, restroom locations, accessibility features for disabled visitors, exit pathways, and guiding

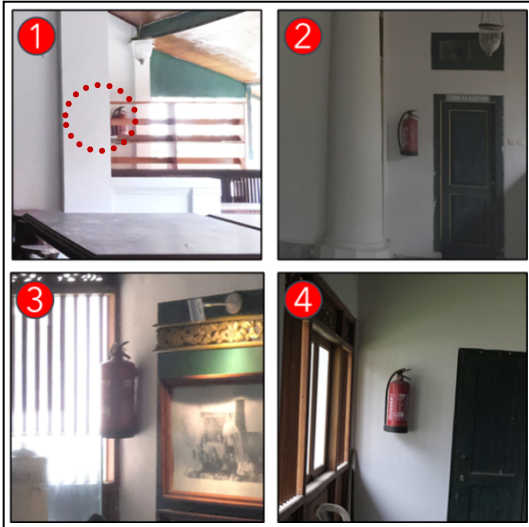
Figure 7. Photos of the existing fire extinguisher at R.A. Kartini Museum Rembang.
 (Source: Personal documentation, 2021)

The fire extinguisher found at the R.A. Kartini Museum Rembang was identified without a marker (signage), making it difficult to find easily. Lack of markings on fire extinguishers can be an obstacle in emergency situations, where fast time and good accessibility are crucial. Therefore, it is recommended to immediately equip each fire extinguisher unit with clear and visible markings to provide clear instructions to visitors and security officers at that location. This action will

Apart from not being equipped with markers, it should be noted that several fire extinguishers in the R.A. Kartini Museum Rembang are also blocked by shelves or columns, and are placed at angles that are inaccessible to visitors or staff during emergency (See Figure 6 & Figure 7). This condition can provide additional challenges regarding accessibility and preparedness in dealing with emergencies. It is recommended to evaluate the placement of the extinguishers, to ensure that they are not only easily visible but can also be reached quickly and efficiently when needed. These steps to improve the placement and accessibility of fire extinguishers will positively contribute to safety and response to potential fires at the R.A. Kartini Museum Rembang.

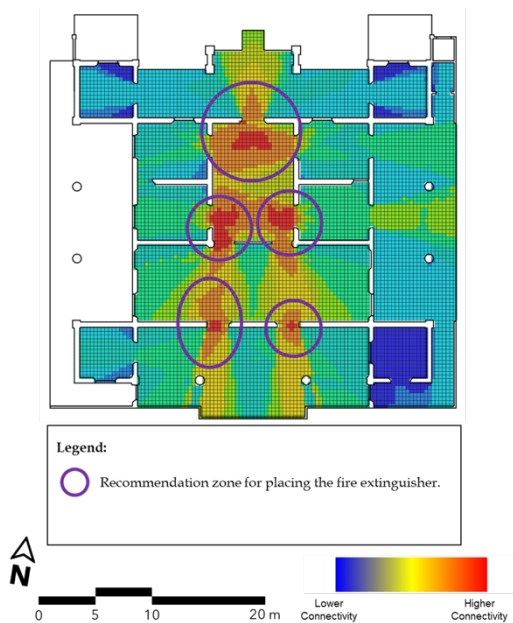
Figure 8. Recommended areas fire extinguisher placement based on VGA results.
(Source: Data analysis)

Visual Graph Analysis (VGA) indicates that the fire extinguisher at point 3 in the Kartini Museum is highly visible to visitors. This placement effectively raises awareness of the extinguishers' presence in the museum. However, it is crucial to ensure that fire extinguishers are visible and easily accessible to increase rapid response in potential fire situations. Periodic evaluation of fire extinguisher placement and availability is vital for maintaining optimal safety levels at the Kartini Museum.

It should be noted that the fire extinguisher located at point 4 in the R.A. Kartini Museum Rembang is inaccessible, and invisible to visitors. This condition is a potential risk in emergency situations, because limited access can hinder rapid response to fires. It is recommended to immediately re-evaluate the

To increase the effectiveness of fire extinguishers at the R.A. Kartini Museum Rembang, it is recommended to place fire extinguishers in five strategic areas to be visible and easily accessible. First, the front terrace area is a potential point because it is often the first area seen by visitors. Second, the living room, which is the main center of activity, could also be the right choice to ensure optimal visibility and accessibility. Third, the family room area can be used as a fire extinguisher point, considering that this room is often used for meetings and other events. Fourth, placement at the main door access point will ensure that the fire extinguisher can be easily reached in
