Analysis Cause of Automatic Voltage Regulator Damage to the Genset in KP Hiu 06 Owned the Ministry of Marine and Fisheries

AVR on an electric generator is a device that serves to maintain the stability of the generator output voltage. KP Shark 06 suffered AVR damage twice in 2017 which affected the operations of the ship so it is necessary to analyze the cause of the damage. The steps to analyze the causes of AVR damage starts from the factor of overload on the electricity generator, the working condition of the electric generator and the motor driving factor of the electric generator. Based on observations and calculations of the ship's electricity load, it is known that there is no overload of electric generators, ie the average per day/hour of power used is 6,009.75 Watt, where the available power is 17,600 Watt (generator efficiency 34.14%). While the work of the generator is observed normally based on the results of the measurement of the electric current produced by the generator. It was concluded that the cause of AVR damage was due to the generator driving motor which experienced a decrease in performance so that when subjected to electric load the engine rotation experien

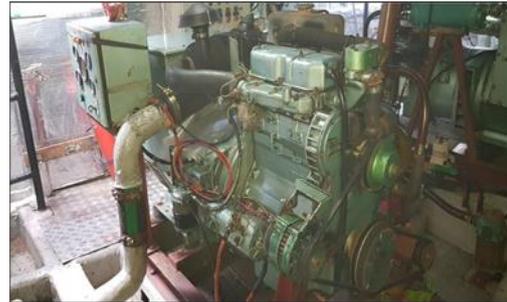
Fig. 1. Genset on KP. Hiu 06

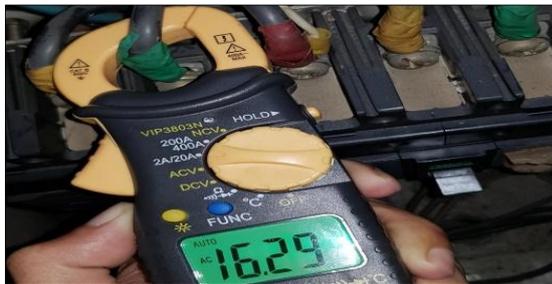
To analyze the electrical overload factor in the generator, data collection is done by measuring the amount of electric current (Ampere), voltage using a clamp meter, and the frequency (Hz) generated by the generator by observing the frequency meter on the electrical panel.

Fig. 3. Measurement of electric current and voltage

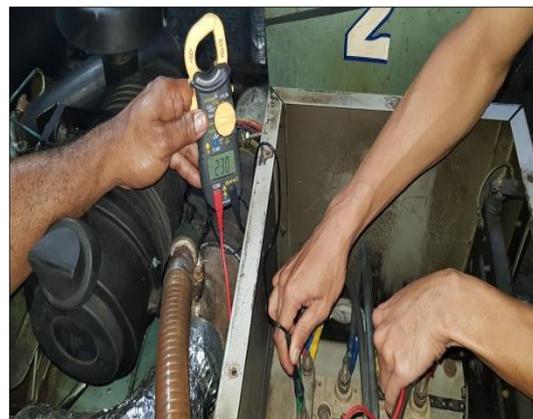
Fig. 5. Check the generator output voltage with neutral

From the results of checks made on the measurement of these generator components as a whole there are some differences from the data contained in the AVO meter measuring instrument showing the voltage generated for the three phases is in the range of numbers namely 360 - 392 Volts and for one phase in the numbers 210 - 230 Volts and for measurements after entering the electric panel also in numbers 360 - 392 Volts and 210-230 Volts, for the PMG system the stator entering into the AVR also shows normal numbers with voltages ranging from 150 Volts AC - 180 Volts AC and for the figures produced for engine speed when normal idle at 1500 RPM but when given a reduced load to 1300 - 1350 RPM to overcome so that the resulting voltage remains at 220 Volts the idle RPM is raised to 1600 RPM so that when given a load will drop to 1500 RPM, but this results in a voltage surge at the beginning of the engine is operated or also when the load is used to change such as the use of air conditioning while the compressor is working and not working there will be changes in engine speed so that the voltage also generated up and down, generator engine RPM often up and down or hunting causing unstable voltage. Changes in load conditions as the dynamic behavior of the system will cause changes in the current flowing in the generator system which causes changes in the voltage of the armature and the generator terminal.

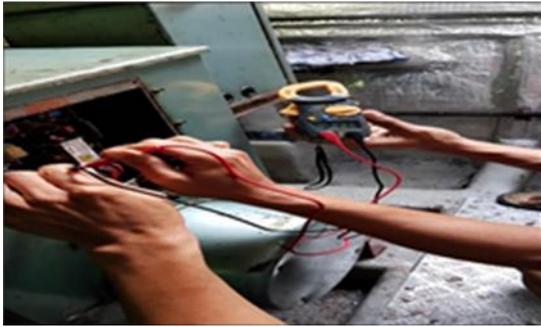
Fig. 6. Voltage check on AVR

exciter stator windings at 13 Volt DC - 60 Volt DC. Other checks in the form of checking the condition of the cable to ensure no cable is peeled or leaking, checking the connection between cables and terminals to ensure no connection is loose, broken or loose, as well as checking the generator mounting bolts to ensure the condition of strength and stability in holding vibration from work generator and motor drive. Based on the above activities, it was observed that the work of the generator was in normal condition, so it was concluded that the AVR damage had not been due to the generator condition.
