Facade Identification of Colonial Buildings in Blitar, Indonesia

ABSTRACT

Blitar is one of the National Heritage Cities in Indonesia. Since 1906, the status of *Gemeente* Blitar has resulted in many relics of colonial buildings in Blitar which are still standing today. Colonial buildings have distinctive shapes and facades. Over time, the facade of the building underwent changes due to the replacement of architectural elements, causing the characteristics of historic buildings threatened to be lost. The aim of this study is to identify architectural elements on the facades of colonial buildings in Blitar City as a way to preserve historic buildings. This study used qualitative with a descriptive approach to describe the physical condition of the building. The results of the research show the characteristics of the facade elements in each colonial building, which can later be used as the basis for the Blitar City Government to make policies related to the preservation of historic colonial buildings.

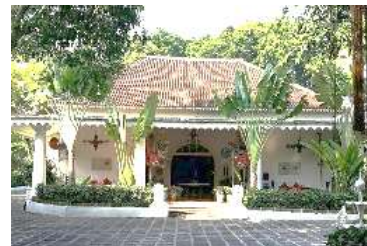
Source: (Antariksa, 2022)
Figure 5: Tugu Sri Lestari Hotel

Hotel Tugu Sri Lestari was founded in 1848 with the *Indische Empire* architectural style.

Initially, this hotel was named Centrum Hotel, because the owner was experiencing financial difficulties, the hotel changed ownership under the management of the Tugu Group in the 1980s. The *Indische Empire* architectural style features a large open terrace without walls with towering Greek pillars supporting the roof [21]. There are four Greek-style pillars with a Tuscan Roman style lined up on the spacious front porch. The characteristics of the *Indische Empire* building are non-rise buildings, have a shield roof type, and there is a classic patterned lipplank around the roof. [12], also fit to the condition of the hotel.

<p>C</p>	-Shield roof type, slope 30° -Roof covering material: tile -There is a classic ornament on the lisplank
