Slope Stability Evaluation and Geometrical Recommendation Using The Morgenstern Price Method

The study is located on PT Indocement Tunggal Prakarsa Tbk., which is still actively engaged in mining operations. The study aimed to determine the slope Safety Factor (SF) and offer suggestions for safe slope geometry for mining operations. Primary data collection through observation of lithology conditions, sample testing in the laboratory, scanline mapping, slope geometry measurements, and secondary data obtained from company inventories and related sources. The kinematic approach is used to assess the risk of landslides. This slope stability study uses boundary equilibrium based on the Morgenstern Price and Mohr-Coulomb failure criteria. Limestone is the majority of the rocks in the location. The kinematic analysis demonstrated that direct toppling and wedge toppling are the landslide potential at the research location. Using the non-circular boundary equilibrium approach, slope stability analysis was carried out on four Regions with dry and saturated groundwater conditions i.e, Regions A', B140, C120, and C135. The four Regions have stable slopes and are in good condition (SF values o

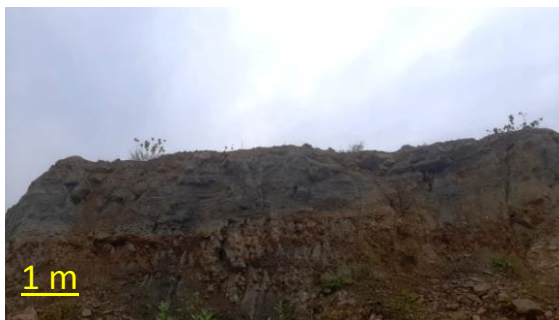
Figure 3. Slope conditions for scanline data in Region A', with the yellow line indicating the length of the scanline.

Sixteen discontinuity regions were discovered in region A' applying slope and scanline orientation data (Table 2). A rough discontinuity area in Region A has been filled with weathered material, primarily mudstone, and has slightly weathered weathering conditions (Figure 3).

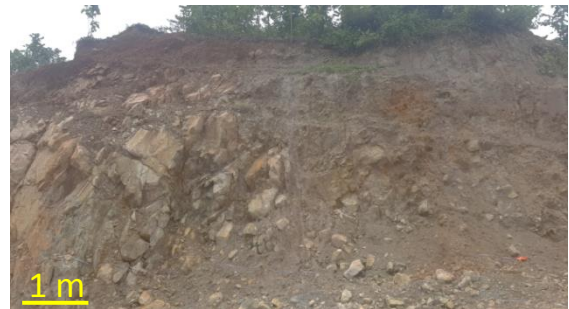
Figure 4. Slope conditions for scanline data in Region B140, with the yellow line indicating the length of the scanline.

Slope and scanline orientation data were used to identify 10 discontinuity locations in Region B140 (Table 3). It has a discontinuity region in Region B140 with a rough surface condition, no material to fill the gaps of the discontinuity area, and a mildly worn weathering level (Figure 4).

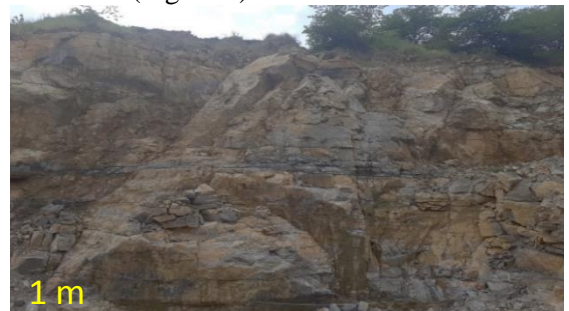
Figure 5. Slope conditions for scanline data in Region C120, with the yellow line indicating the length of the scanline.

Using slope and scanline orientation information, 19 discontinuity locations in Region C120 were identified (Table 4). It is a discontinuity region with a rough surface condition in Region C120, no material used to fill in the gaps, and a gently weathered weathering level (Figure 5).

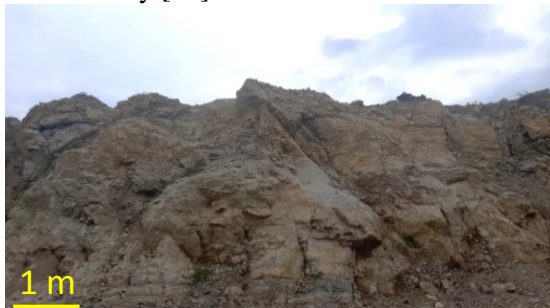
Figure 6. Slope conditions for scanline data in Region C135, with the yellow line indicating the length of the scanline.

Sixteen discontinuity areas were found with slope and scanline orientation data in Region C135 (Table 5). In the gaps of the discontinuity area, filling material in the form of weathered material, particularly mudstone, and slightly weathered weathering conditions have been identified (Figure 6).

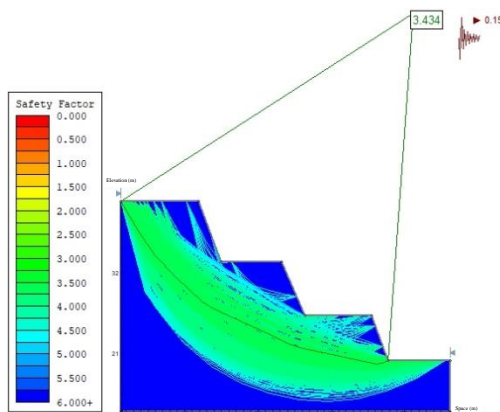
Figure 12. Region A' with Dry Conditions, SF 3,434.

SF values under dry and saturated groundwater conditions were obtained in evaluating slope stability measurements for Region A'. Region A' has an SF value of 3.434 in dry groundwater conditions (Figure 12), though it has an SF of 2.358 in saturated groundwater conditions (Figure 13).

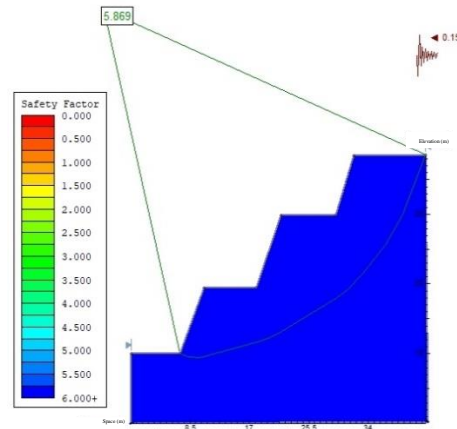
Figure 14. Region B140 with Dry Conditions, SF 5,869.

SF values for dry and saturated groundwater conditions were obtained in the framework of slope stability measurements for Region B140. Region B140 has an FS value of 5.869 at saturated groundwater conditions and 4.603 for dry groundwater scenarios (see Figures 14 and 15).
