## Analysis of Coastline Changes with the Utilization of Geospatial-Based Sentinel Imagery

Birto Karlos<sup>1\*</sup>, Meilani Belladona<sup>2</sup>, Supriyono<sup>3</sup>

<sup>1,2,3</sup>University Prof. DR. Hazairin, SH. Bengkulu, Jl. Ahmad yani No. 1, Bengkulu 38115, Indonesia

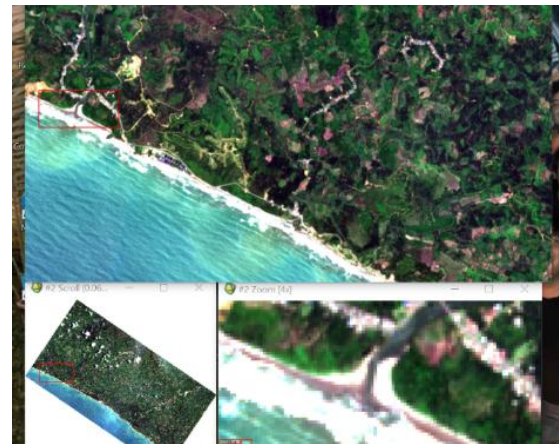
**Figure 3.** The image of 2024 has not been corrected (Source: Researcher)

This image is the result of initial processing of surface reflectance data (BOA Reflectance) at level 2A, but has not yet gone through the geometric correction process. From the visual appearance, it can be seen that some features on the surface, such as rivers, roads, and vegetation boundaries, are misaligned and distorted. The position of the object still refers to the coordinate system of the satellite sensor, so it is not entirely accurate when compared to reference maps or other spatial data.

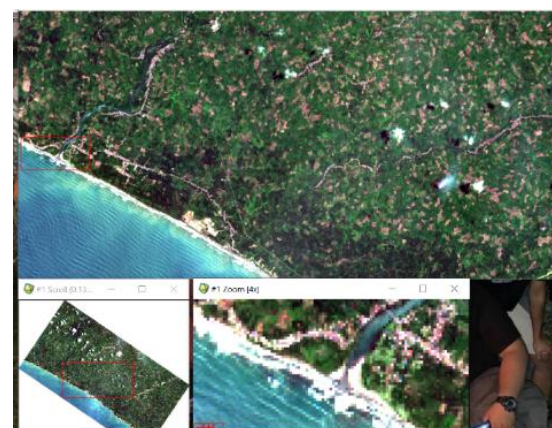
**Figure 4.** Image 2024 Geometric correction results (Source: researcher)

This figure is the result of a geometric correction process applied to similar data, where each pixel has been adjusted to its actual spatial position on the earth's surface. Thus, the resulting image becomes more accurate in terms of geographical position. Features such

as rivers, roads, and land boundaries now look more aligned and reflect their original shape consistently. The coastline also appears smoother, and the zoomed in objects (with 4x zoom) look more precise and clear. The correction process is carried out without changing the reflectance value, so that the color and spectral information remain consistent with the initial image, but coupled with a much higher level of spatial accuracy.

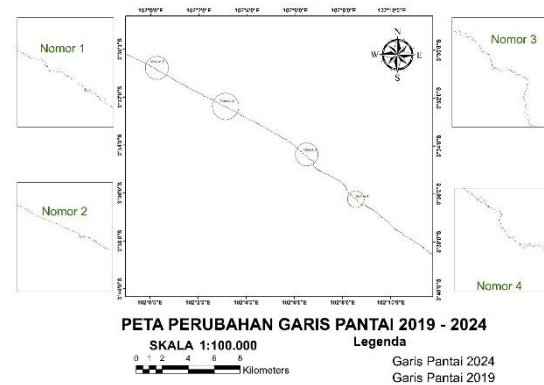
**Figure 6.** Map of coastline changes  
*Source: researcher*

Changes in the coastline that occurred in Lais District, Air Besi District, and Air Napal District, North Bengkulu. The coastline changes studied for the period 2019 to 2024 cover all coasts of Lais District, Air Besi District, and Air Napal District, North Bengkulu. The coastline per year that has been generated previously is displayed so that changes can be seen.

Based on the value of the Average Table of Coastline Changes above, there are several areas that have experienced severe erosion such as Air Padang with an average change of 16,468 M, Dusun Raja with an average change of 8,690 M, Pal 30 with an average change of 10,911 M, Pentangkak with an average change of 9.7 M, Lubuk Tanjung with an average

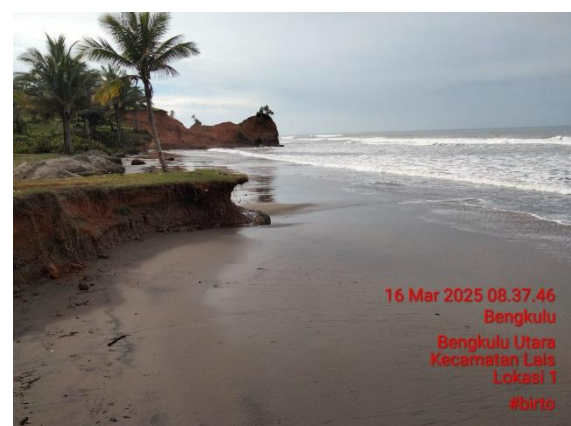
**Figure 9.** Field Documentation

The soil around the coastline looks eroded, even some coconut trees are in an alarming position, close to the side that has landslided. To handle this situation, the right mitigation strategy is needed so that the damage does not

spread further and endanger the surrounding environment.

The initial steps taken in disaster mitigation can take several steps such as planting coastal vegetation. Plants such as sea spruce, beach grass, or even mangroves if conditions allow the tide of sea embankments can help break up high waves, strengthen soil structure and reduce the rate of abrasion caused by waves.

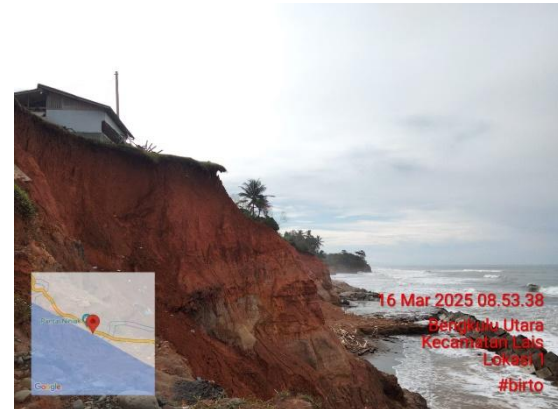
**Figure 12.** Field Documentation of Dusun Raja (Source: researcher)

Extreme abrasion that has caused the red earth cliff to collapse vertically, threatening the buildings of residents standing on the lip of the cliff so that it requires quick and thorough handling.

With the creation of physical structures to strengthen the bedside, such as multi-level guardrails using boulders or concrete, as well as the installation of gabions or ground ties to strengthen the slope from the inside. Moving buildings that are located too close to the cliff is also very important to do in order to avoid the possibility of loss of life if a landslide occurs again.

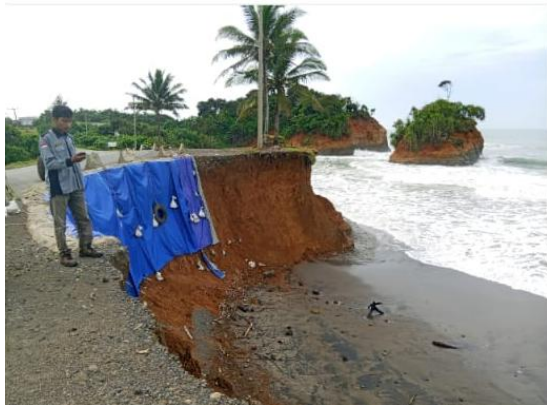
**Figure 14.** Field Documentation of Pal Village 30 (Source: researcher)

Given the damage to the road due to coastal abrasion, proper preventive measures are needed to avoid further damage as well as protect the infrastructure and the surrounding environment. Structurally, one of the main solutions is the construction of a coastal embankment that functions to prevent waves from directly hitting cliffs or roads. In addition, the installation of a breakwater in the sea can also reduce the strength of the waves before reaching the shore.

Planting coastal vegetation such as mangroves, sea spruce, or other plants with strong roots is also very effective in preventing soil abrasion naturally. Reinforcement of the road structure, including repairing the foundation and changing paths if necessary, needs to be considered, especially if the area is a zone prone to high abrasion. A good drainage system must also be implemented so that rainwater does not worsen erosion from the land.

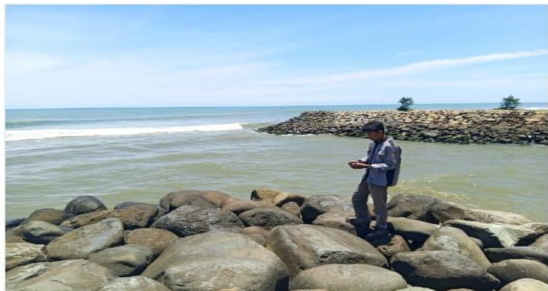
**Figure 18.** Field Documentation of Lubuk Tanjung Village (*Source: researcher*)

There is an effort to reduce coastal abrasion by building a breakwater structure made of large rocks. This structure plays a role in reducing the strength of sea waves so that they do not directly hit the beach, so that it can slow down the occurrence of abrasion. Although this method is a fairly effective mitigation strategy structurally, additional steps are also needed such as planting coastal plants to strengthen the stability of the soil naturally, as well as regular maintenance of breakwater rocks so that they continue to function properly. In addition, community participation and the application of modern monitoring technology are also important elements in supporting the continuity of coastal area protection. The combination of technical and ecological approaches will create more comprehensive

and responsive mitigation efforts to ongoing environmental changes.

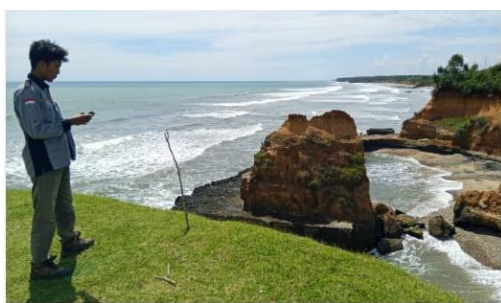
**Figure 22.** Field Documentation of Pal Village 30 (Source: researcher)

The coastal areas that can be seen show signs of quite serious abrasion, as seen from the cliffs eroded by the sea waves that hit continuously. Various systematic mitigation measures need to be implemented. One way that can be taken is to plant coastal vegetation such as sea cypress trees, sea pandanus, or mangroves in the appropriate area. These

plants play a role in preventing erosion by binding the soil and dampening the force of the waves. In addition, the installation of protective structures such as breakwaters, retaining walls, or breakwater structures can also help reduce the impact of waves directly hitting cliffs. Coastal spatial planning is crucial so that development does not get too close to the coastline that is vulnerable to erosion.
