Efficiency Analysis of Ripple Mill Capacity 6 Ton/Hours on Maintenance Machine

Ahdiat Leksi Siregar^{1*}, Riyansa Devi Zulfiah², Istianto Budhi Rahardja³, Azhar Basyir Rantawi⁴, Hendra Saputera⁵

^{1,2,3,4,5} Politeknik Kelapa Sawit Citra Widya Edukasi, Gapura 8 street, Rawa Banteng, Setu, Cibitung, Bekasi, 17520, Indonesia

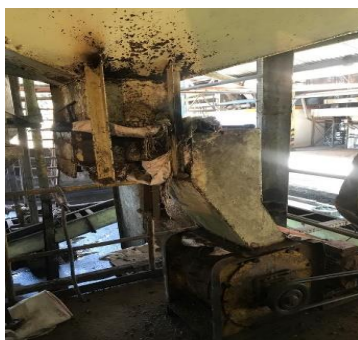
Figure 1. Ripple mill

Ripple mill is a machine at the nut & kernel station which functions as a tool for breaking palm kernels, namely separating the palm oil shell from the palm kernel or kernel. The way the ripple mill itself works is that the palm seeds (nuts) that are fed into the ripple mill will be ground and crushed between the stationary stator bar and the moving rotor bar. The working results of this ripple mill depend on the size of the palm kernels being fed, filling too much palm kernel will cause the rotor and stator to experience wear and tear and the operating hours of the ripple mill will exceed its useful life. These things will influence whether the ripple mill machine is effective or ineffective.

Ripple mill is a tool for breaking palm kernels, separating the shell from the kernel. In the ripple mill there is a moving part called the rotor bar, where this component is designed to consist of 40 hard bars (bars) and has a support called a dish, there are 4 dishes which are used to support the bar so that it does not shift and has a shaft to rotate the rotor. The rotor bar works at a fairly high rotation speed with the aim of producing an efficiency of 95% - 99%. The shaft on the rotor bar is supported by 2 bearings which can be adjusted and lubricated. The silent part of the ripple mill is the stator bar. The palm kernel (nut) will be fed from the nut hopper into the ripple mill and there will be a

process of impacting and pressing repeatedly between the stator bar and the rotor bar. The rotor accelerates the movement of the palm kernel during the impact process, forcing the shell of the palm kernel to break and separate from the kernel. To obtain optimal solving efficiency, things must be considered:

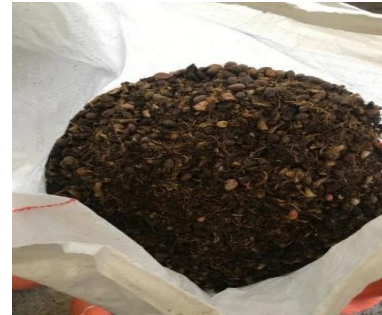
Figure 2. Cracked Mixture

The material that goes as feed into the ripple mill is palm kernel (nut), where the palm kernel will be stored first in the nut hopper before entering the ripple mill.

This efficiency is a measure of success which is assessed in terms of how large or small the results of a machine's work are. According to Siregar (2018), cracked mixture consists of several materials, such as heavy material, namely kernels and round nuts, medium material, namely broken kernels and broken nuts, and light material, namely shell. To calculate the efficiency of a ripple mill, you can use the following equation:

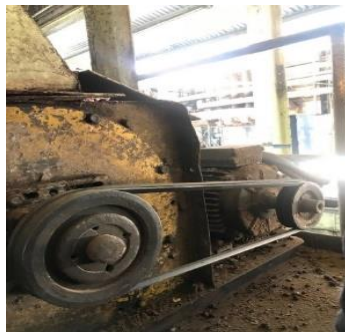
Figure 6. V-Belt Pulley

A V-Belt is a belt or belt made of rubber and is used as a tool to transmit power from one axis to another by rotating a pulley at the same or different speeds.

The V-Belt Pulley used at PT UWTL is the Bando Type B65 and B67 models. Where the use of the v-belt is in accordance with the position of the motorbike.

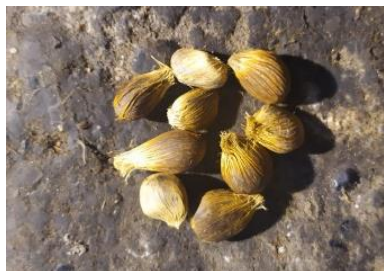
Figure 9. fiber included in the nut

d. The cleanliness of the fiber that is still included in the nut will directly affect the level of efficiency.

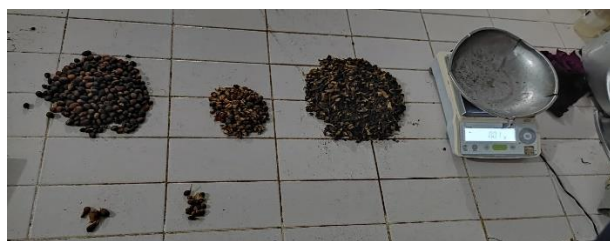
Figure 10. Round nuts, round kernels, broken kernels, and broken nuts

- Prepare a sample container and tools for taking samples.
- Take a sample of the cracked mixture at the output of the cracked mixture conveyor then weigh 1000 gr to the nearest gram (W1).
- Separate the cracked mixture based on categories, namely round nuts, broken nuts, whole kernels and broken kernels.
- Each category is weighed to the nearest gram respectively as W2 W3 W4 and W5
- Calculate the efficiency of the ripple mill
- The following is data on the results of adjustments and replacements on the ripple mill machine.

- Sample = 1000.29 grams
- Round nut = 6.78 grams
- Broken nut = 7.37 grams
- Round kernels = 267.10 grams
- Broken kernels = 86.58 grams

$\% \text{ Round Nut} = (6,78 \text{ gr}/1000,29 \text{ gr}) \times 100\% = 0,68\%$
 $\% \text{ Broken Nut} = (7,37 \text{ gr}/1000,29 \text{ gr}) \times 100\% = 0,74\%$
 $\% \text{ Round Kernel} = (267,10 \text{ gr}/1000,29 \text{ gr}) \times 100\% = 26,70\%$
 $\% \text{ Broken Kernel} = (86,58 \text{ gr}/1000,29 \text{ gr}) \times 100\% = 8,65\%$
 $\text{Efficiency} = 100 - \% \text{Nut Whole} - \% \text{Nut Broken}$
 $\text{Efficiency} = 100\% - 0,68\% - 0,74\% = 98,58\%$
